RE: Observations and Recommendations for Existing Italy City Hall Building

EXHIBIT A
WEST BUILDING

EXHIBIT B
EAST BUILDING

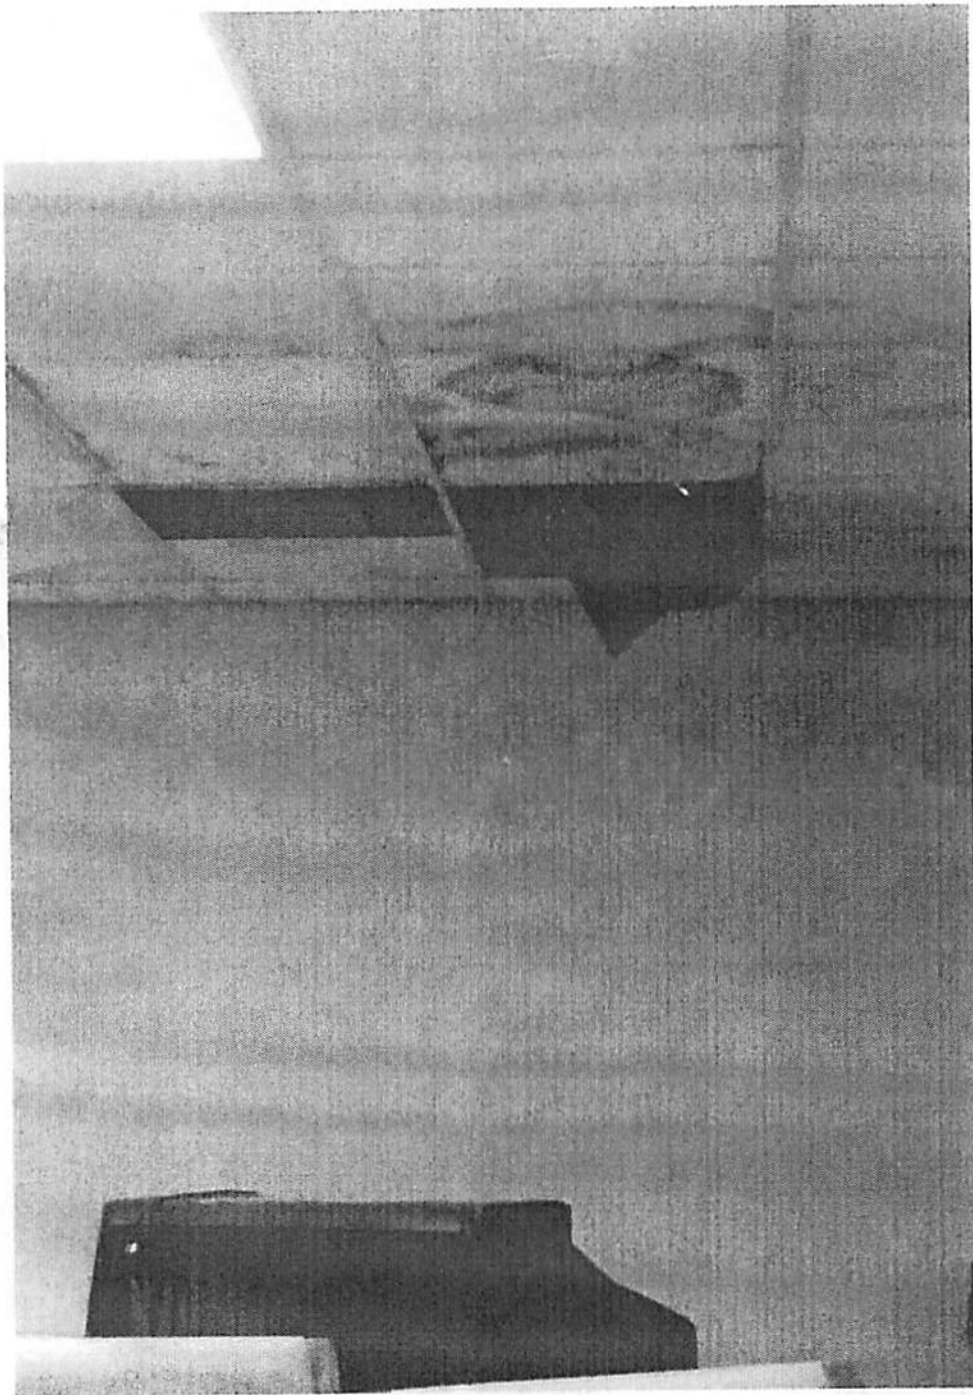
1. Water damage was visible in numerous locations including:
 - a. Suspended acoustical tile ceilings above the council chambers and municipal offices.
 - b. Wood ceilings both concealed by the first floor suspended ceilings and exposed on the first and second floors of the east building.

SUSPENDED ACOUSTICAL TILE CEILINGS

8. All other water damaged materials should be removed and replaced.
9. A fire suppression system may need to be installed.
10. The HVAC system may require improvements, or at least cleaning to eliminate mold and condensation.

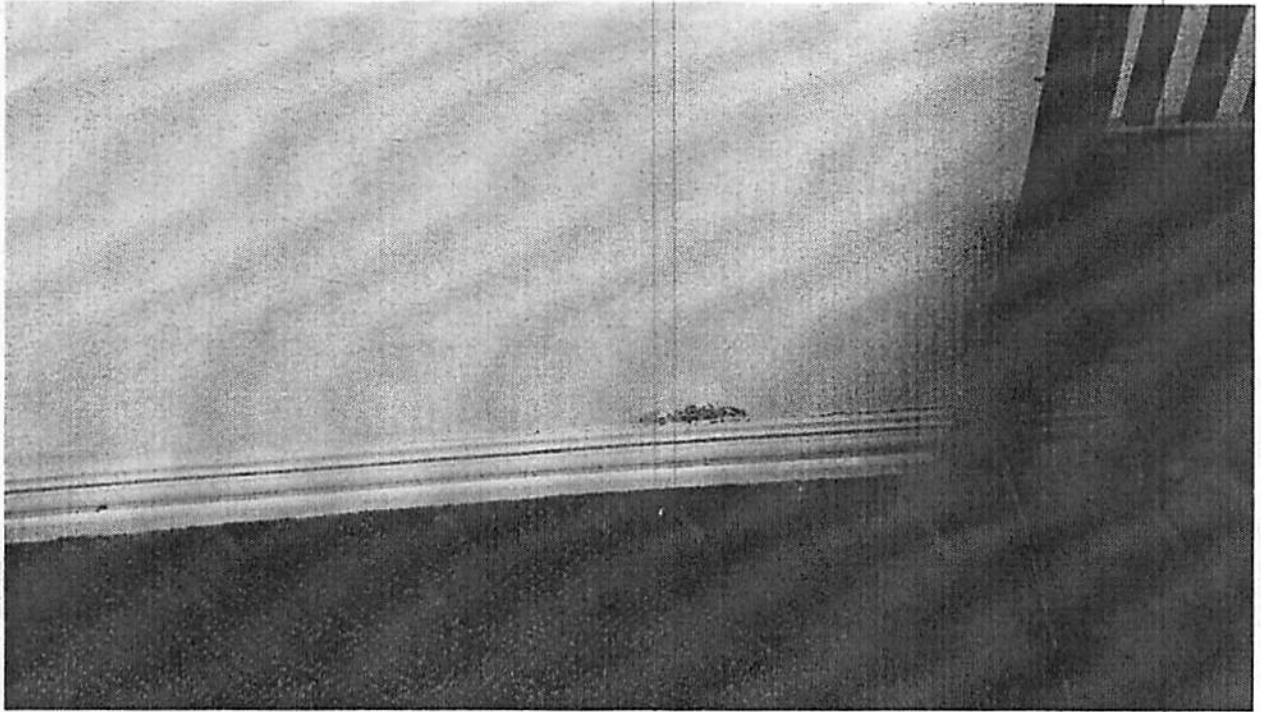
- e. Supply air diffuser in the first floor men's restroom.
 - f. At the base of the gypsum board wall between the council chambers and break room, on the break room side.

SIGN OF MOLD AT BASE OF GYPSUM BOARD

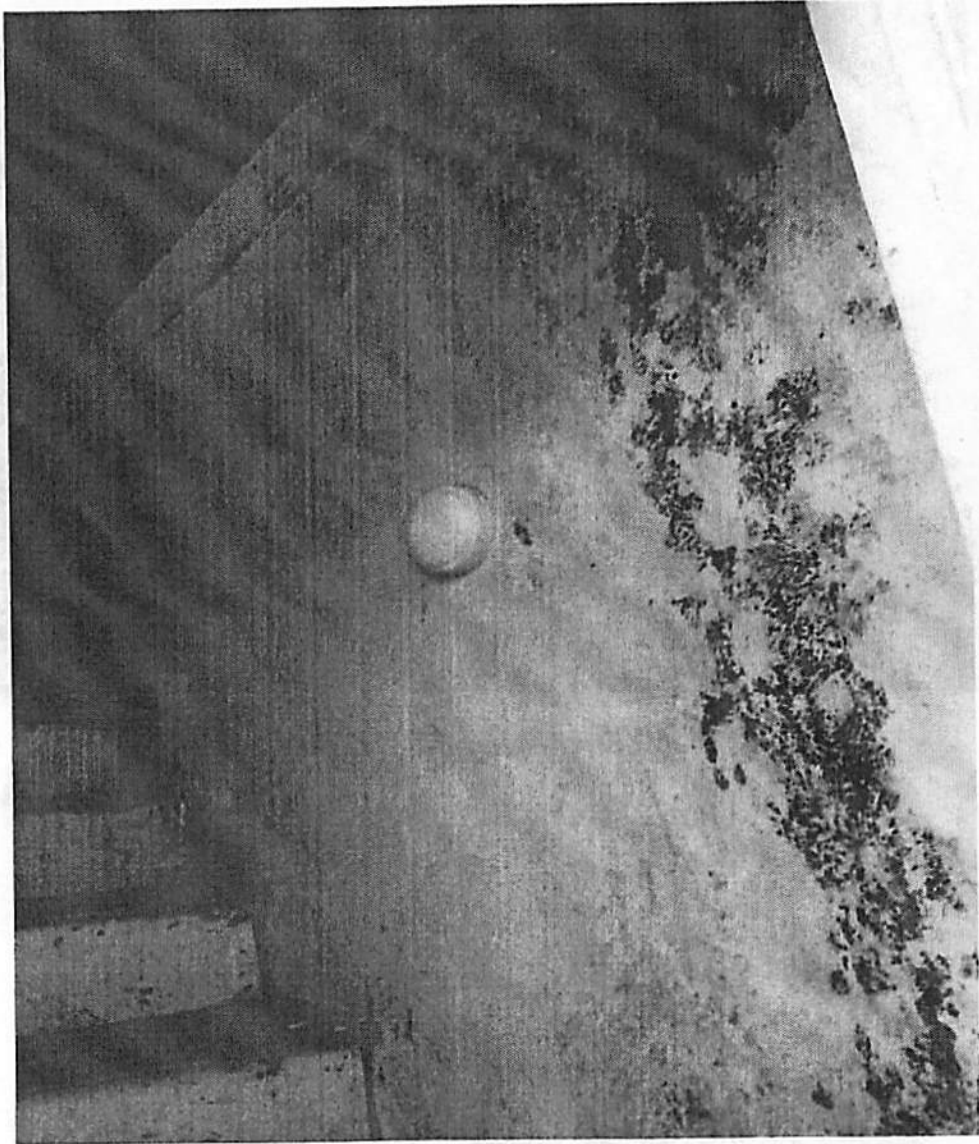
3. We observed signs of mold in several locations including:
 - a. Gypsum board ceilings in the second floor storage area of the west building.
 - b. The wall at the base of the stairs from the second floor storage area of the west building.

POTENTIAL MOLD ON WALL AT THE BASE OF THE STAIRS

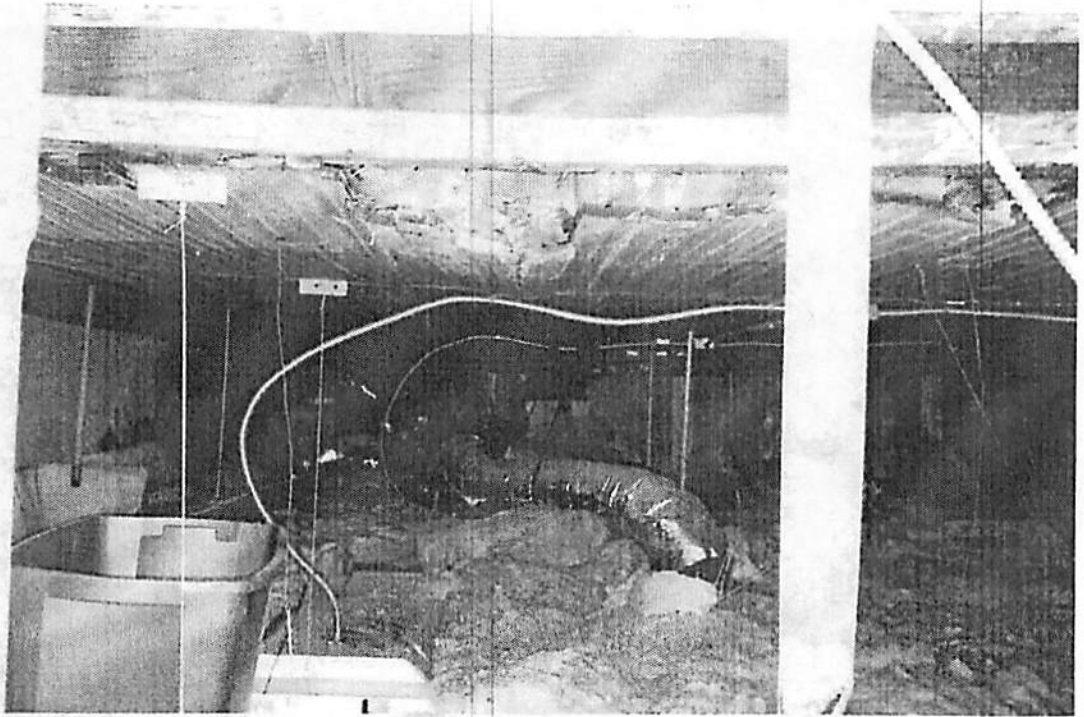
STRUCTURAL DAMAGE TO CEILING ABOVE COUNCIL CHAMBERS

2. Some of the wood floor and roof structure may need to be repaired or replaced, and protected with fire resistant material.
3. The roof coverings may need substantial repairs, or even replacement. If multiple layers of previous roof coverings are enclosed between the current metal roof, and the original wood roof deck, they may need to be removed to allow for new roof coverings and insulation, and to eliminate deteriorating material and/or trapped moisture within the roof assembly.

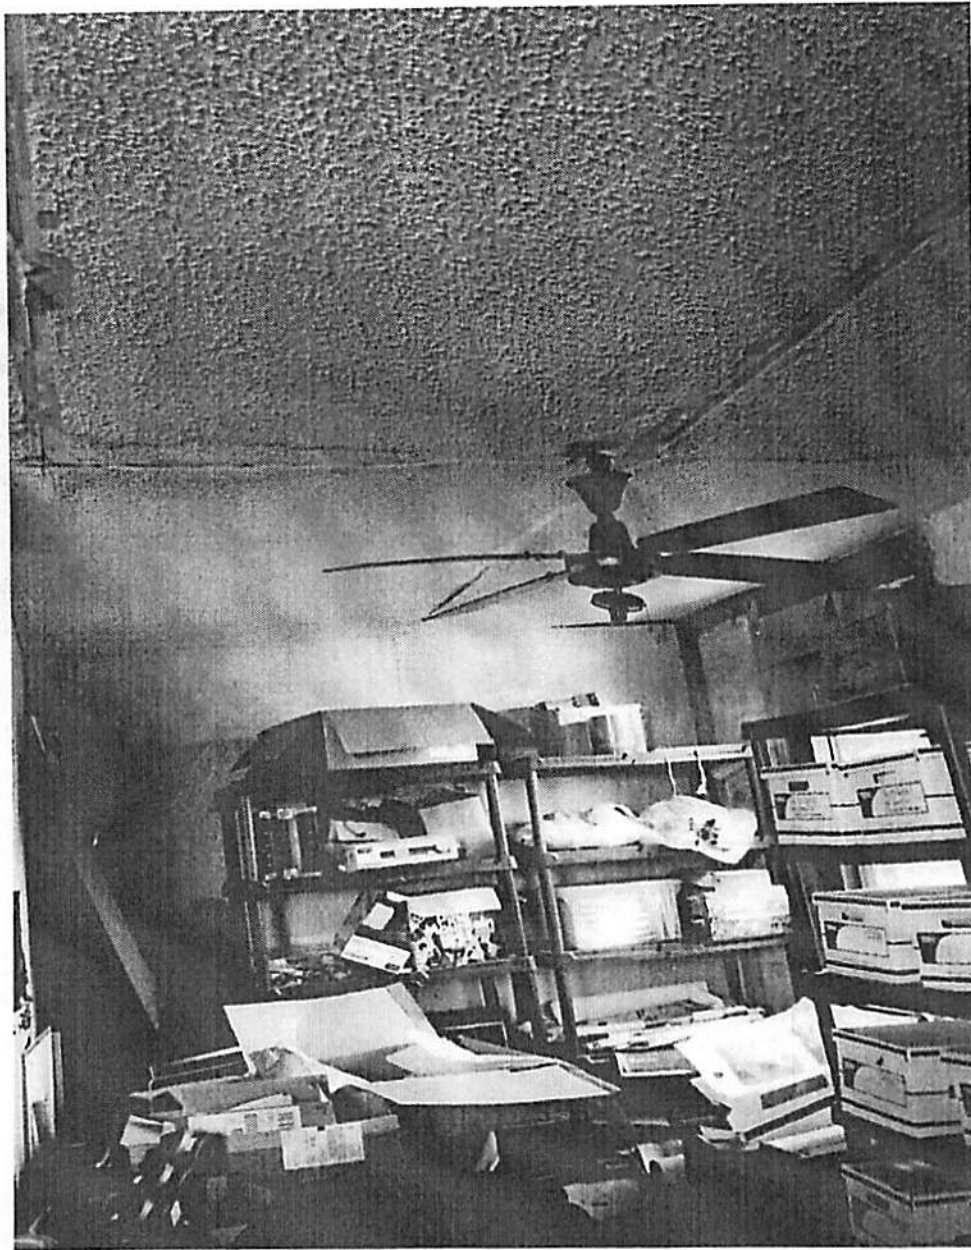
- c. Exposed masonry walls inside the second floor storage area of the west building.
 - d. Gypsum board ceilings in the second floor storage area of the west building, men's restroom, and the second floor of the east building.

WATER DAMAGE IN STORAGE AREA ABOVE COUNCIL CHAMBERS

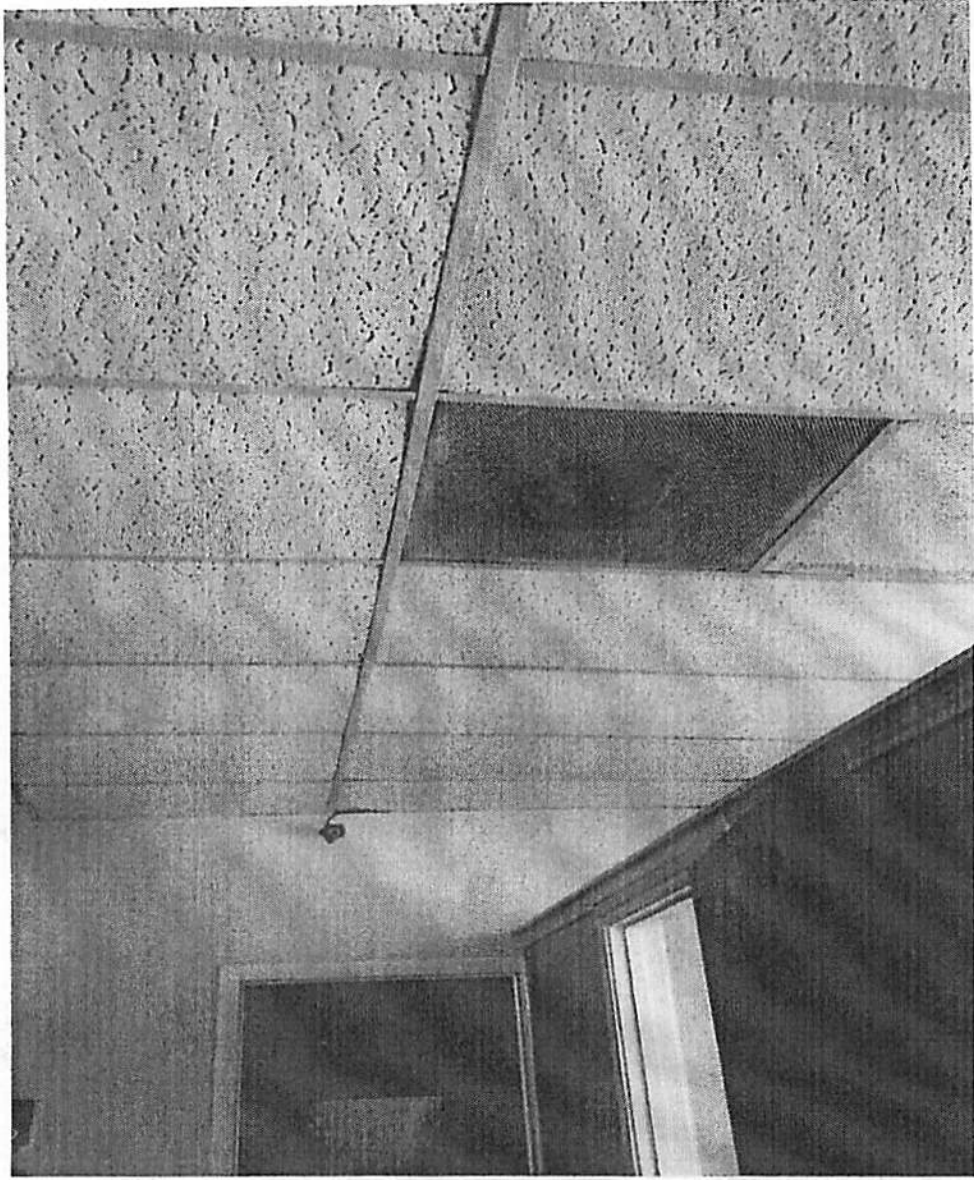
- c. Wood ceilings at the north end of the first floor, and on the second floor, of the east building.
 - d. Supply air diffusers on the first floor of the east building.

MOLD ON AIR DIFFUSERS

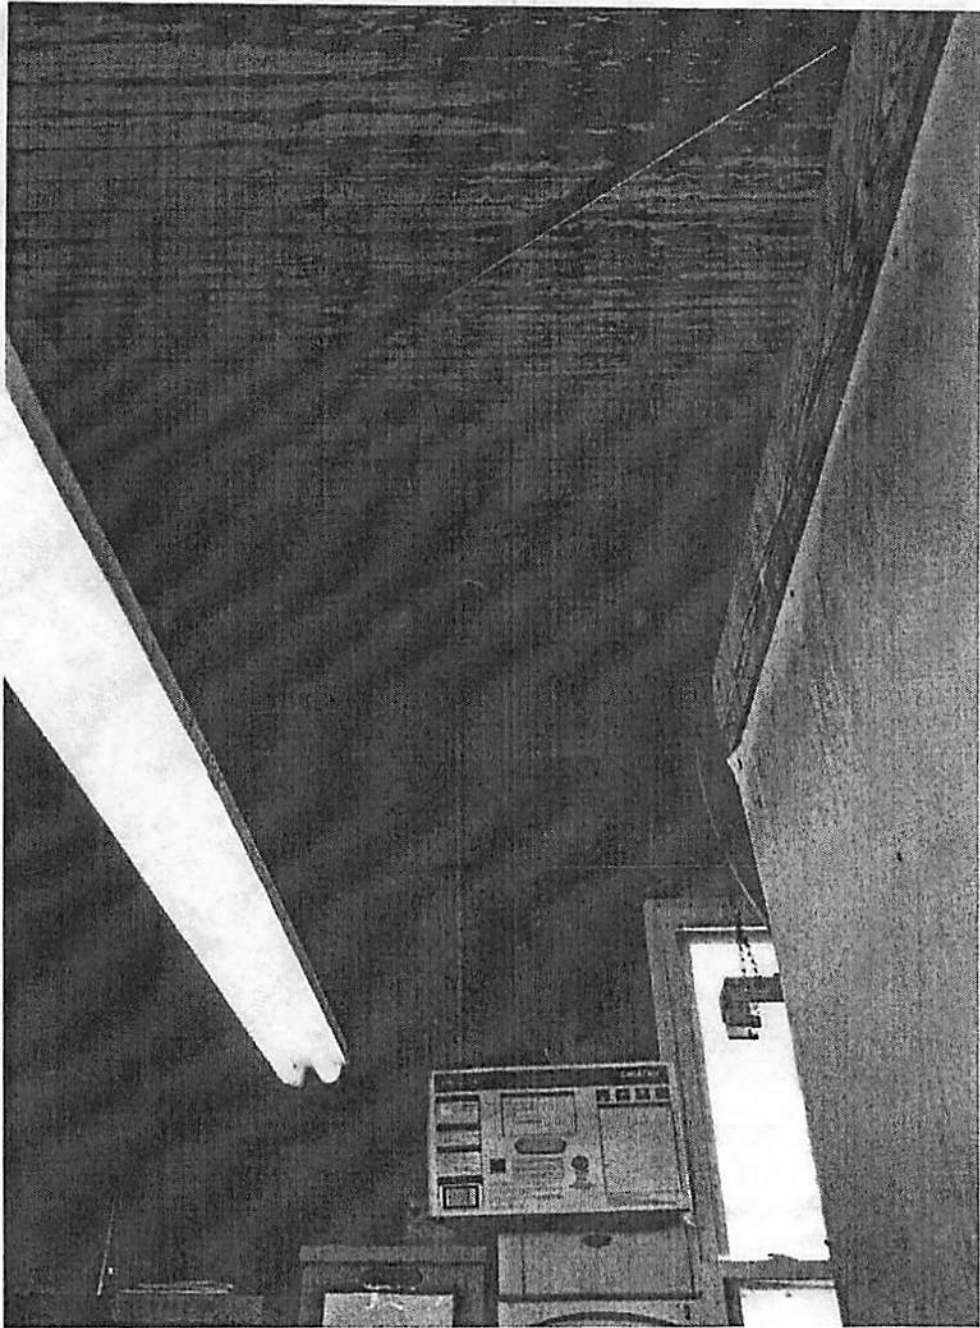
10. The transaction counter in the public lobby of the east building is not ADA/TAS compliant.
11. Electrical wiring at the north end (back) of the first floor of the east building is insulated with plastic sheathing, but not in conduit. It is stapled to a wood ceiling. Wire splices are visible outside junction boxes. Generally, building code requires all electrical wiring in commercial construction to be placed in conduit, and all splices should occur within junction boxes.

EXPOSED ELECTRICAL WIRING AND WATER DAMAGE

11. All wiring of the electrical system needs to be placed in conduit and junction boxes.
12. The buildings should be made ADA/TAS compliant. This will likely require substantial remodeling of doorways, door hardware, cabinets, counters, and restrooms. Repositioning of light switches and other controls accessible to building occupants may be required. If the second floor of the east building is to be occupied, an elevator will likely be required to make it accessible. All required means of egress must be made accessible including an accessible route to ground level.

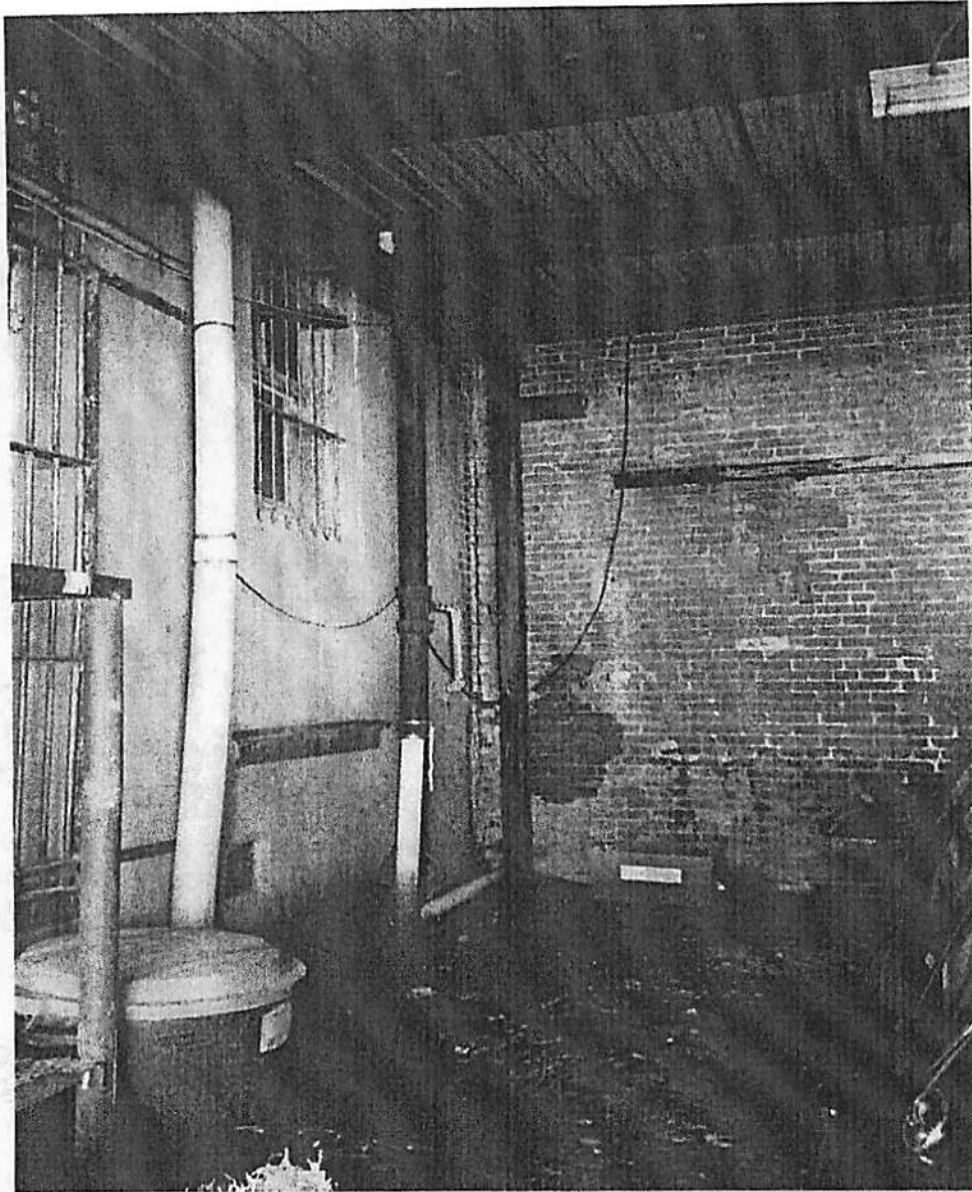
16. Sanitary sewer drain/vent pipes are exposed on the exterior face of the north wall of the east building. One of these appeared to be leaking at ground level, inside the sallyport.

POTENTIAL SEWAGE LEAK IN SALLYPORT

5. The leaking sewer drain pipe should be repaired, and exposed plumbing should be insulated and enclosed. Damaged cast iron pipe may need to be replaced with PVC.

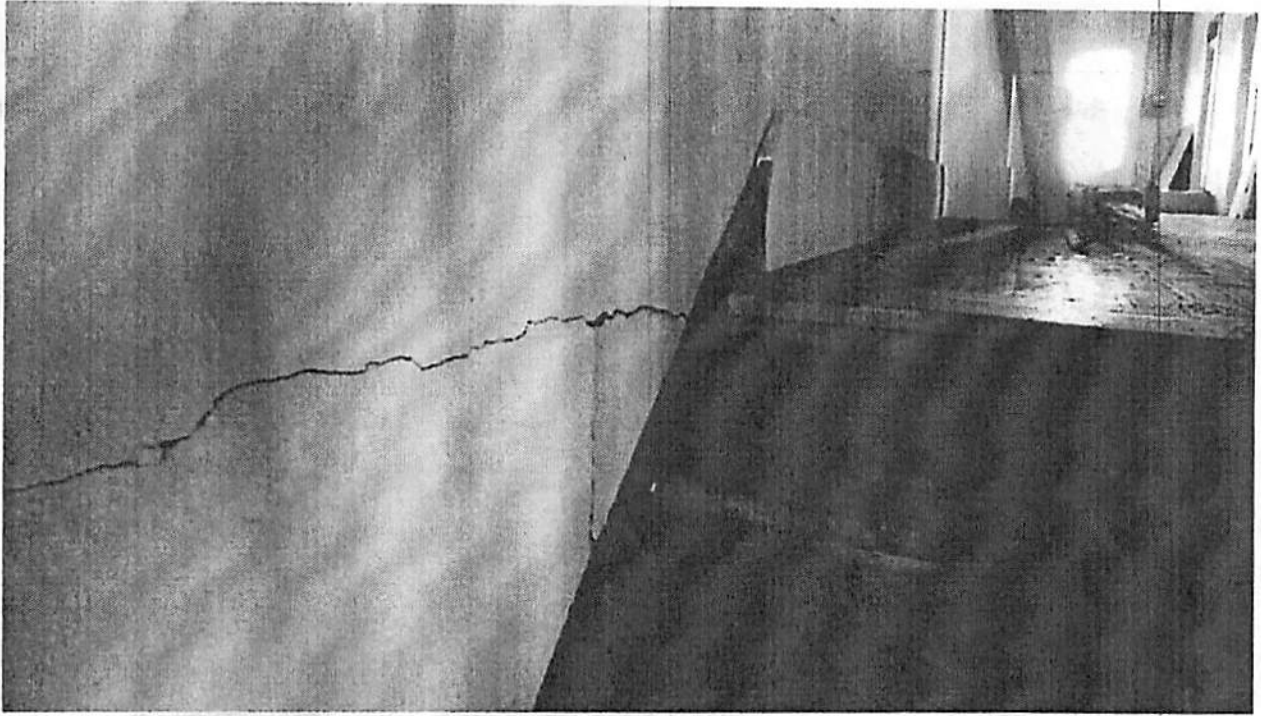
STRUCTURAL DAMAGE ON STAIRWELL OF 2ND FLOOR

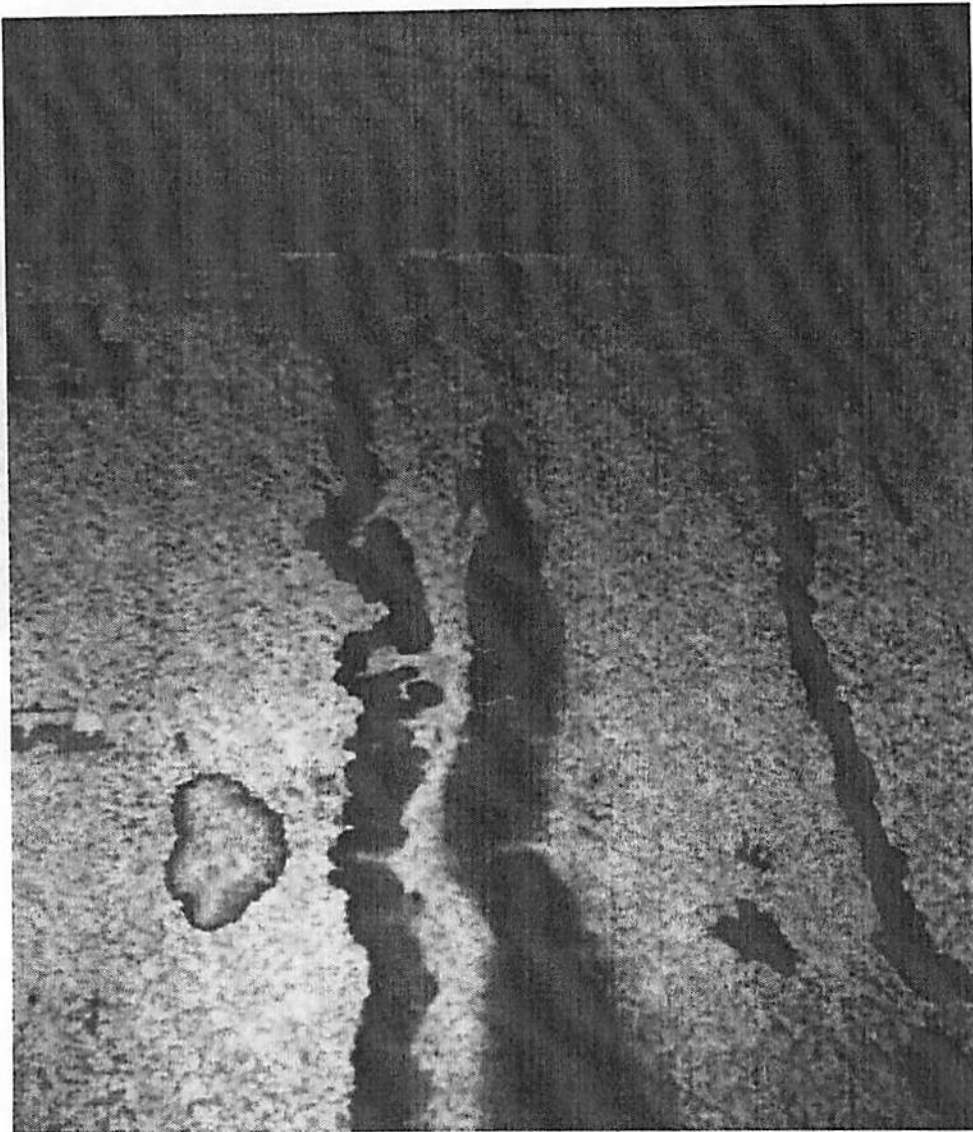
WATER DAMAGE ON 2ND FLOOR

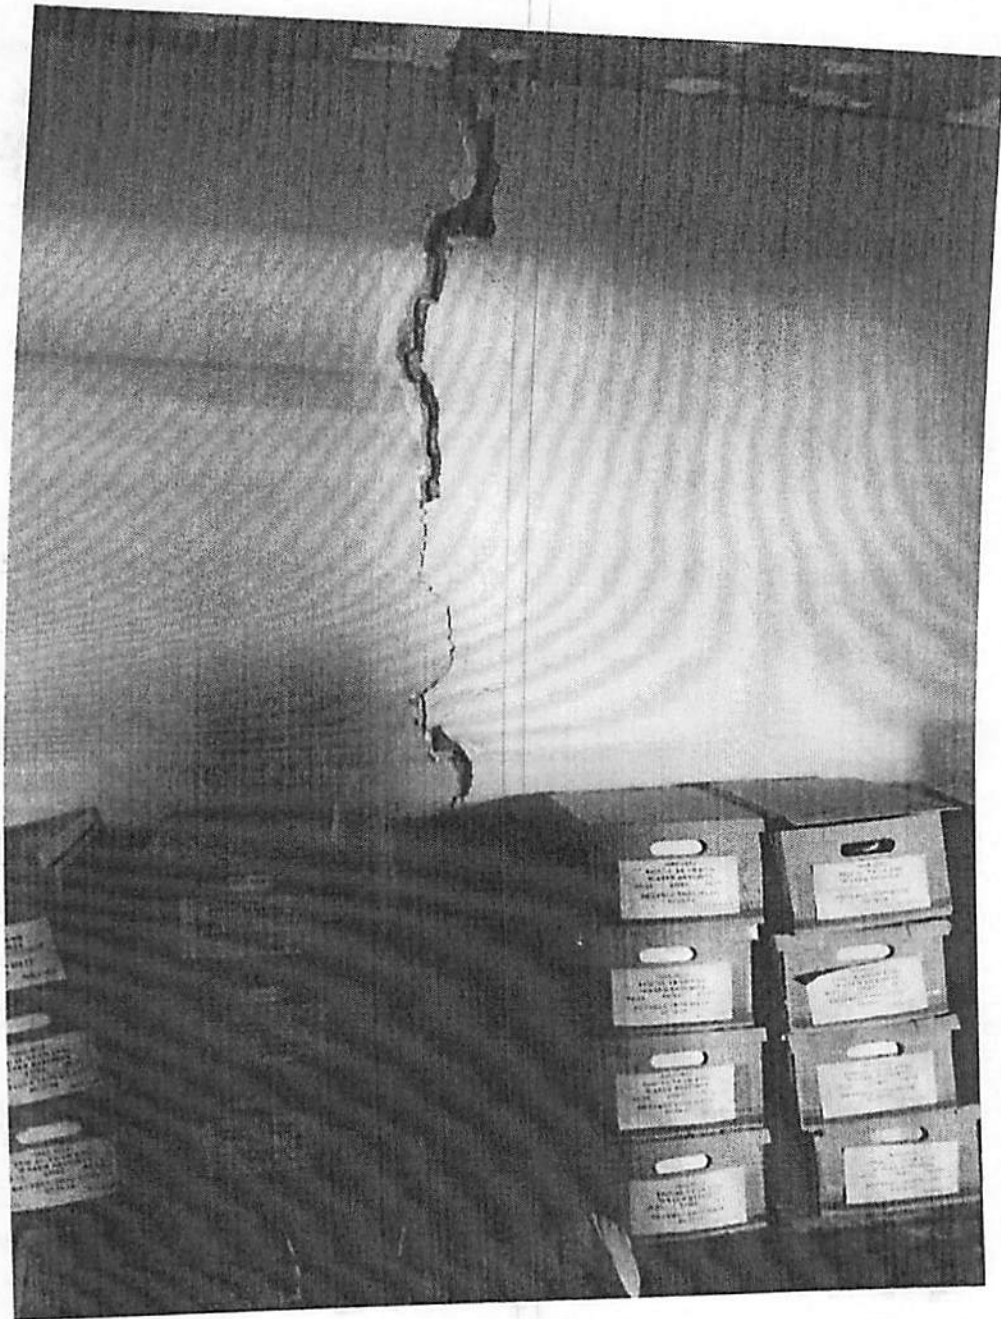
14. The brick party wall and exterior walls on the second floor are covered with plaster which is cracked in several locations. This could be indicative of cracking in the underlying brick. One crack in the party wall appears to be a structural crack through the brick.

STRUCTURAL DAMAGE IN PARTY WALL ON 2ND FLOOR
